## Mechanical Properties of Ancient Clay Bricks of Jethawana Sthupa

M.P.R.N.Gunasinghe, B.A. Karunaratne\*

Faculty of Applied Sciences, Rajarata University of Sri Lanka.

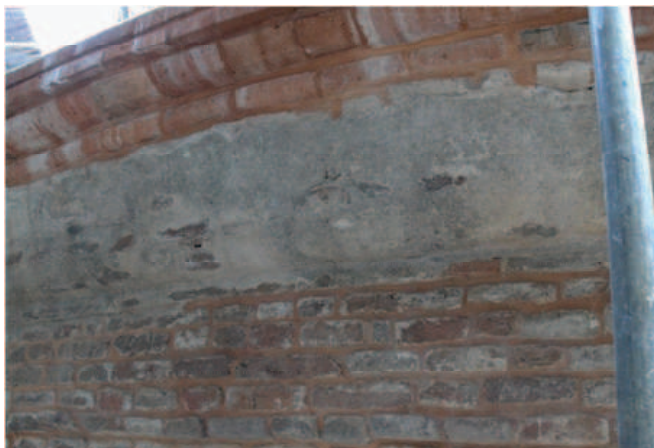
Figure 3. Bricks used to construct the spiral of Jethawana sthupa.

The main building block of the sthupa is burnt clay brick (Figure 3). The bricks in the sthupa are different in sizes. The ancient bricks used to build the sthupa are much larger than modern clay bricks. Bricks of different sizes have been used for different parts of the sthupa <sup>7</sup>, larger ones for the basal rings and dome, and much smaller one for the spiral.

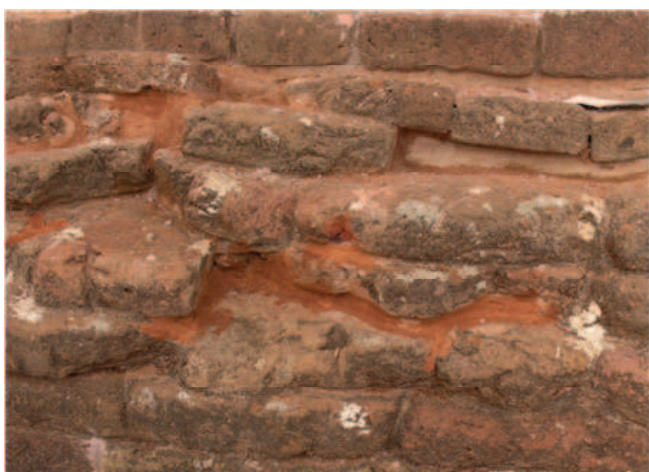
Figure 4. Mortar used in the square chamber of Jethawana sthupa (reddish colour area is the mortar which is used for the conservation).

The mortar used in Jethawana sthupa construction is very thin and fine butter clay like slurry (Figure 4). The thickness of the mortar is about 5 mm. With this thin mortar, the bricks essentially sit one on top of the other, the slurry filling the gaps. This gives a strong brick work unlike the modern brick works which uses a thick mortar which can weaken the brick work.

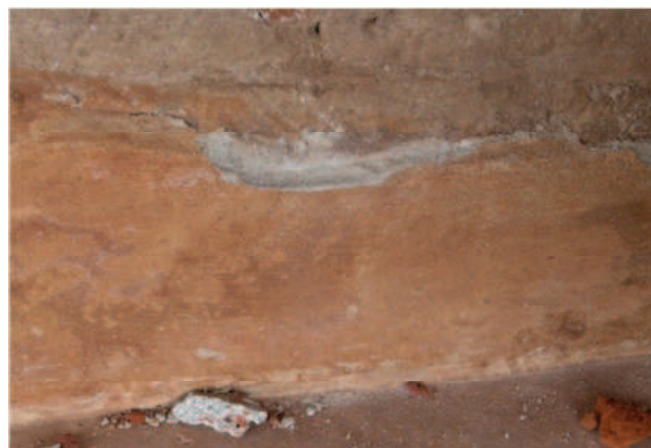
Figure 5. Outer plaster of the square chamber of Jethawana sthupa.

The outer surface of the brick work is water proofed using a thick (thickness - 1.5 cm) plaster (Figure 5).

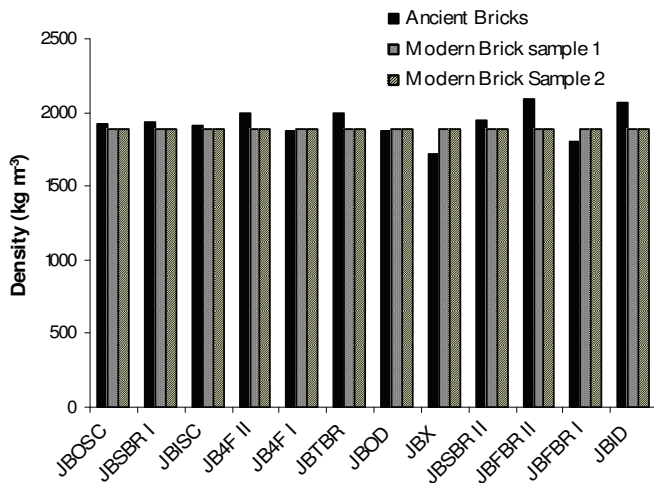
OSC - Outside of Square Chamber, SBR - Second Basal Ring, ISC - Inside of Square Chamber, 4F- 120 cm Below the Ground surface, TBR - Third Basal Ring, OD - Outside of Dome, X -unknown, FBR - First Basal Ring, ID- Inside of Dome

Figure 7. Density of the bricks of Jethawana sthupa (JB).

There was no significant difference in the value of the densities of the ancient brick and new bricks (Figure 7).

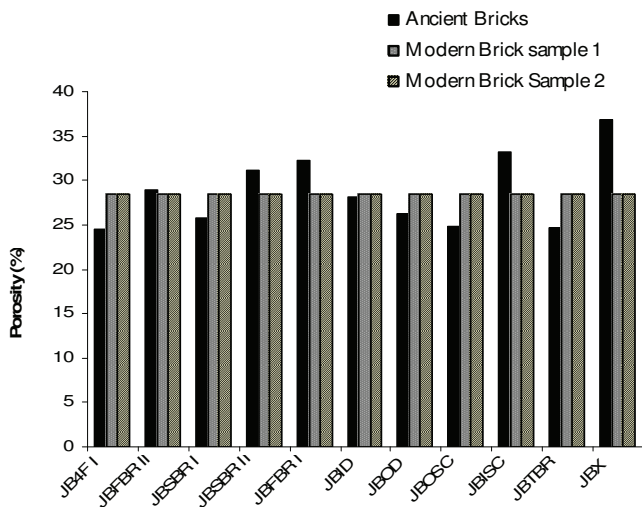
4F- 120 cm Below the Ground surface, FBR I - First Basal Ring, SBR II - Second Basal Ring, ID- Inside of Dome, OD - Outside of Dome, OSC - Outside of Square Chamber, ISC - Inside of Square Chamber, TBR - Third Basal Ring, X -Jethawana Bricks unknown

Figure 8. Porosity of the bricks of Jethawana sthupa (JB).

Porosity of the bricks in foundation, second basal ring, outer cover of the dome, outer cover of the square chamber and the third basal ring is lower than that of the modern bricks. Porosity of the bricks in first basal ring, inside the square chamber and the brick from the site area is greater than that of the modern bricks (Figure 8).

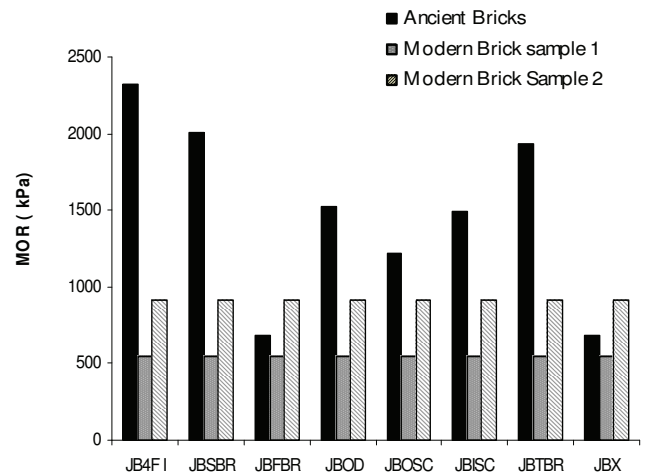
4F- 120 cm Below the Ground surface, SBR II - Second Basal Ring, FBR I - First Basal Ring, OD - Outside of Dome OSC - Outside of Square Chamber, ISC - Inside of Square Chamber, TBR - Third Basal Ring, X -Jethawana Bricks unknown

Figure 9. Modulus of rupture of the bricks in Jethawana sthupa (JB) in kPa showing high MOR value for ancient bricks.

MOR value of ancient bricks was found to be higher than that of new bricks used for reconstruction except those ancient bricks collected from the first basal ring and ancient bricks collected from the site area (exact position of the brick is unknown). Highest MOR values were shown for the bricks which were collected from the foundation from the second basal ring and from the third basal ring (Figure 9). Even after exposing to weather changes, and mechanical forces for more than 1700 years still they show a higher value for MOR than for modern bricks.

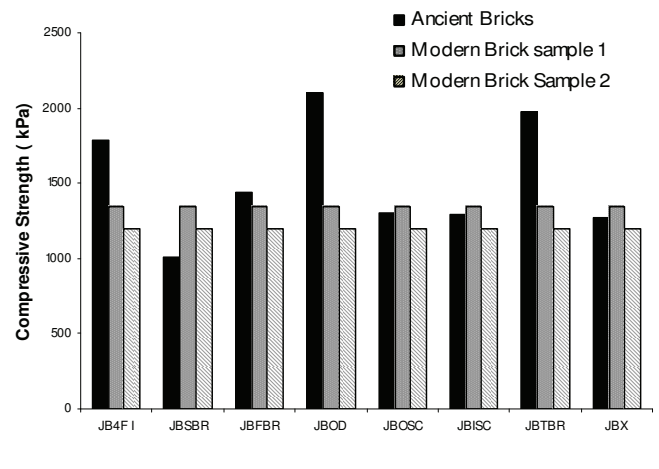
4F- 120 cm Below the Ground surface, SBR II - Second Basal Ring, FBR I - First Basal Ring, OD - Outside of Dome OSC - Outside of Square Chamber, ISC - Inside of Square Chamber, TBR - Third Basal Ring, X -Jethawana Bricks unknown

Figure 10. Compressive strength of the bricks of Jethawana sthupa (JB).

Maximum compressive strength was shown for

the bricks from the foundation, from the outer cover of the dome and from the third basal ring (Figure 10). Compressive strength of ancient bricks from other places did not show much difference from the values of the modern bricks. This may be due to the weathering of the bricks and exposure to high compressive forces for long time. Almost all the ancient bricks showed very high value for critical stress intensity factor than for modern bricks. Most bricks from the places like foundation, outer

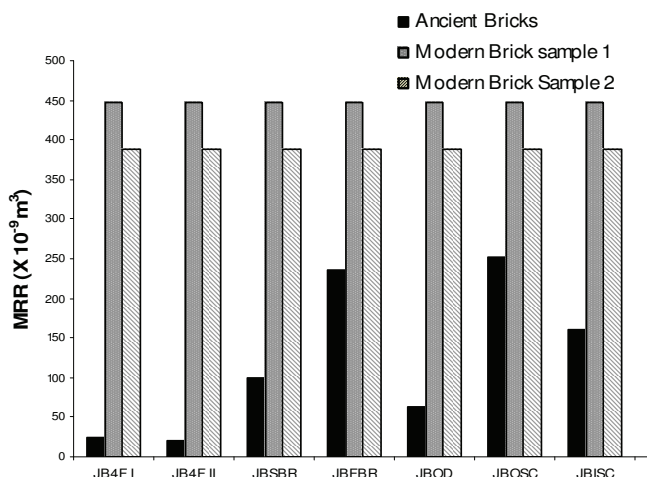
Figure 12. Material removing rate of the bricks of Jethawana sthupa showing low MRR for the ancient bricks.

bricks is very low than that of the modern bricks (Figure 12) and it is nearly one tenth of that of the modern bricks. This is not valid for the ancient bricks which were collected from the site area (the exact place where it was in the sthupa is unknown). Ancient bricks are much more resistance to wear than the modern bricks.
